Best Practice Recommendations for Wall Retrofit on the Two-Story Flexible Research Platform (FRP) at Oak Ridge National Laboratory (ORNL)

Wall retrofit strategies for retrofit on the interior side of masonry wall construction for existing commercial buildings.

November, 2016

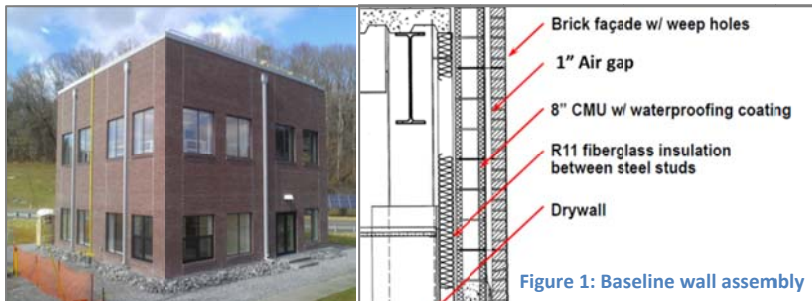
Two-Story Flexible Research Platform at ORNL

The baseline envelope system for the FRP was built to represent the wall systems typical of the majority of the existing commercial buildings built prior to the 1980s located in the 10-county region surrounding Philadelphia (Otto K., 2011^{1**}). This analysis was based on CBECS and COSTAR data.

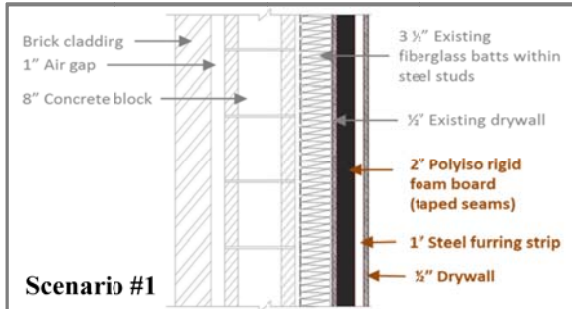
Scenario #1

Figure 2: PIR (polyisocyanurate) foam board installed over existing wall assembly.

- Assembly has existing insulation and
- Existing insulation is in effective condition.

PIR foam boards with coated-glass facers were installed over the existing drywall. The seams for the board were taped according to manufacturer’s recommendation and the junctions and penetrations were effectively sealed. The roof to wall junction was sealed using closed-cell spray foam application.

Thermal Performance: PIR foam board, installed as continuous insulation over existing wall assembly, provided an overall R-value of R-20.7.

Moisture vapor permeance: The coated-glass faced PIR foam board served as Class III vapor retarder.

Air permeance: The PIR foam board with low air permeance, taped seams and sealed junctions served as the air barrier layer within the assembly.

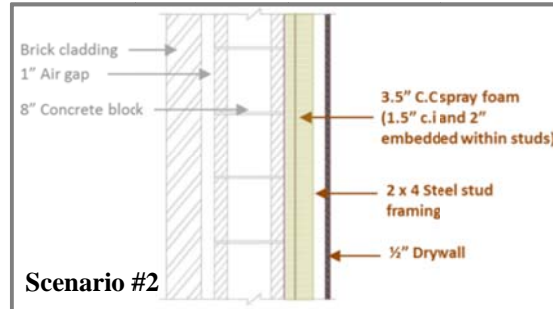
Scenario #2

Figure 3: Closed-cell (C.C) spray foam installed continuous (c.i) over inside face of concrete block

- Assembly has no existing insulation or
- Existing insulation is in poor condition and requires removal.

The existing fiberglass insulation and drywall were removed. The existing steel studs were offset 1.5” from the concrete block wall. Then 1.5” of closed-cell spray foam was installed between the studs and the bare concrete block wall, which provided a layer of continuous insulation. Lastly, 2” of spray foam was installed between the studs.

Thermal Performance: Closed-cell spray foam installed as a seamless insulation layer provided an overall R-value of R-21.6.

Moisture vapor permeance: Closed-cell spray foam serves as Class II vapor retarder with less than 1 perm vapor permeance at 1.5”.

Air permeance: Closed-cell spray foam is considered air impermeable at minimum 3/4”.

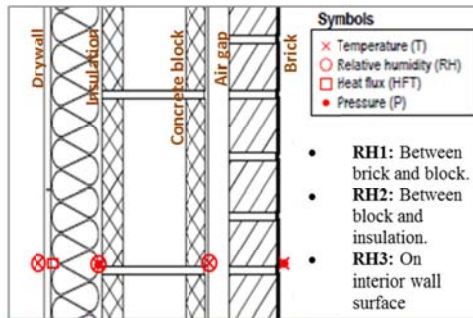
Three types of data were collected for each retrofit; interior and exterior temperatures, heat flux, and moisture performance. The moisture content within the wall assembly was measured using three relative humidity sensors - RH1, RH2 and RH3, and the locations can be found in Figure 4. Both retrofits occupied the North-West zone of the FRP. The spray foam retrofit took place on the first floor (1F), while the PIR retrofit took place on the second floor (2F). Data was analyzed for a random week each month from September to February.

Figure 4: Sensor layout within the baseline exterior wall assembly for the two-story Flexible Research Platform.

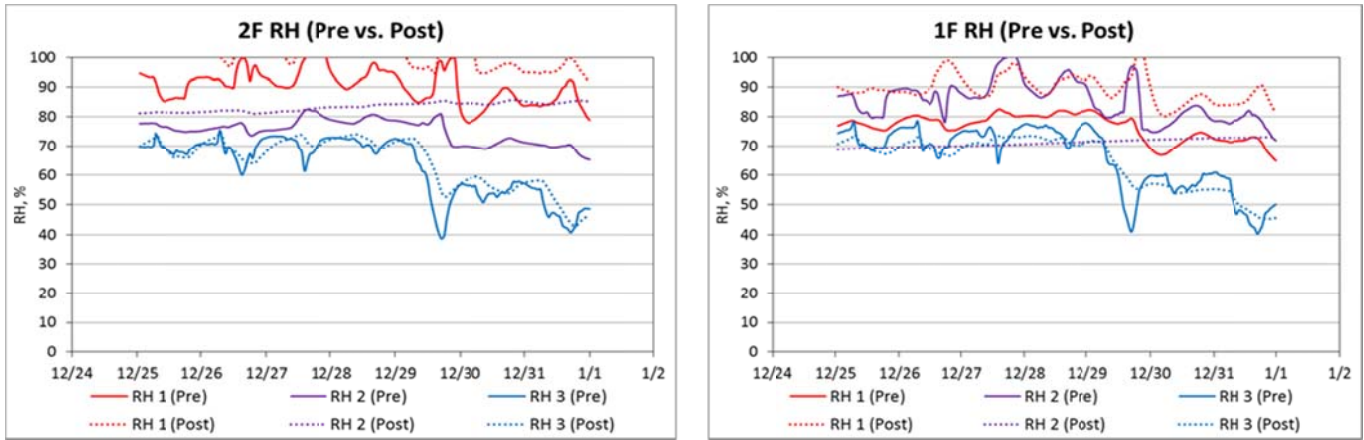
Figure 5 indicates the hourly values for moisture content measured by the sensor located between the insulation and the masonry wall (RH2) for the two scenarios for a typical week in December. The trends observed for moisture content were similar for both the scenarios with moisture contents staying well within safe levels. Table 3 shows the sensor maximum, minimum, and average values for the same one week/month interval. Although there are short term peaks in the moisture content that exceeded the mold criteria threshold (approximately 84%), these peaks are for a fairly short duration. The spray foam retrofit (1F RH) has some periods of moisture content at 100 percent relative humidity; the PIR retrofit (2F RH) does not exhibit this behavior.

Figure 5: Moisture Performance Analysis for the Two Scenarios Based on RH2 Sensor

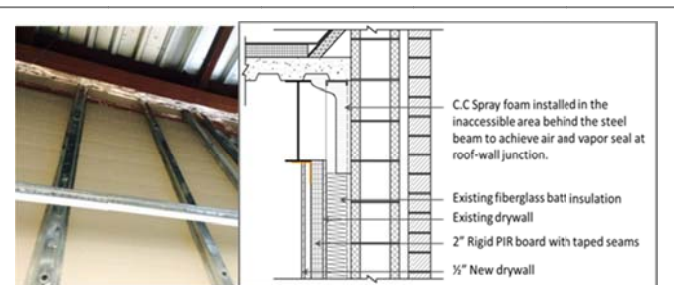
Figure 6: The presence of 12” deep steel beam underneath the roof deck for the FRP made the roof-to-wall junction inaccessible for installing rigid PIR foam boards. Spray foam was used to seal this junction.

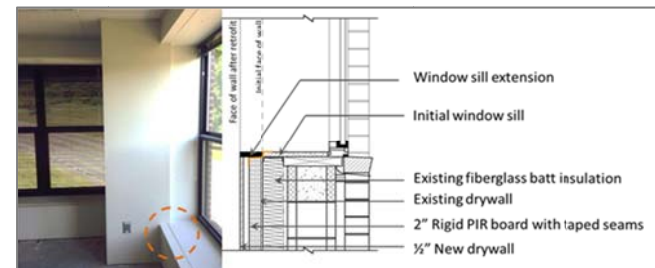
Figure 7: Extended window sill over additional retrofit components

- Maintaining the air and moisture seal for the PIR board layer was challenging in critical areas which were not readily accessible.
- The increased wall thickness for this scenario required addressing details such as extending window sills.

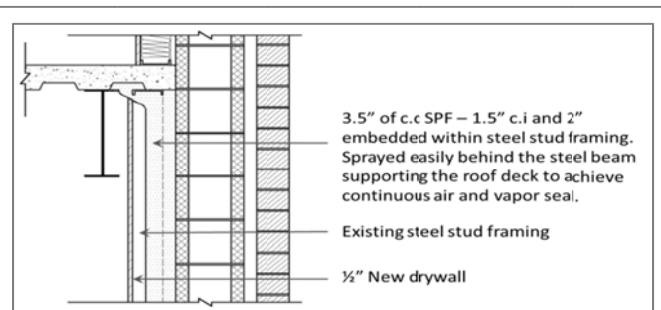
Figure 8: Roof-to-wall junction behind the steel beam sealed effectively with spray foam.

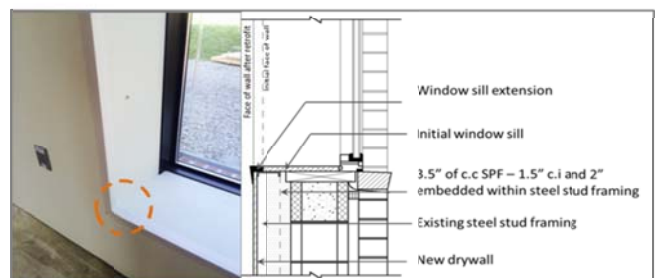
Figure 9: Extended window sill over additional retrofit components

- This offset of 1.5” required the window sill to be extended.
- Installation of closed-cell spray foam required a certified spray foam contractor.
- Closed-cell spray foam layer served as thermal insulation as well as air and moisture barrier; thus, eliminating the need to involve multiple trades.
